REPORT NUMBER: WI-16-99

**FLOWABLE FILL AS BACKFILL
FOR
BRIDGE ABUTMENTS**

FINAL REPORT

Research Study # 99-05
Report # WI-16-99

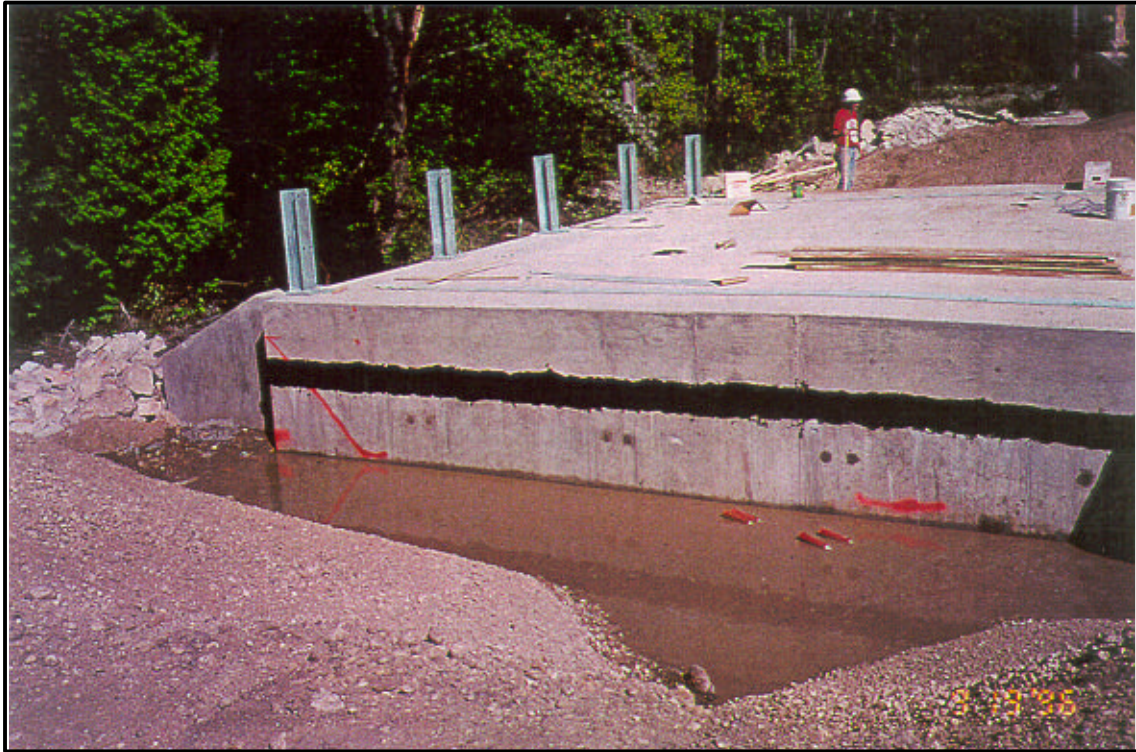
Print 1 - CTH D (Mink Creek) West bridge abutment. Notice standing water in trench.

However, due to rainy weather, 1-2 ft. of water was present in the trench. Granular backfill was used to “push” the water out, leaving the trench saturated. This was done to meet Department of Natural Resources (DNR) beneficial reuse requirements, which prohibits the placement of CLSM in standing water¹. Thus the depth of the trench was reduced from 5 ft. to 3 ft. at the face of the abutment and extended for a distance of 15 ft. from the face of the abutment instead of the originally designed distance of 25 ft. The tapered design was used to minimize the potential

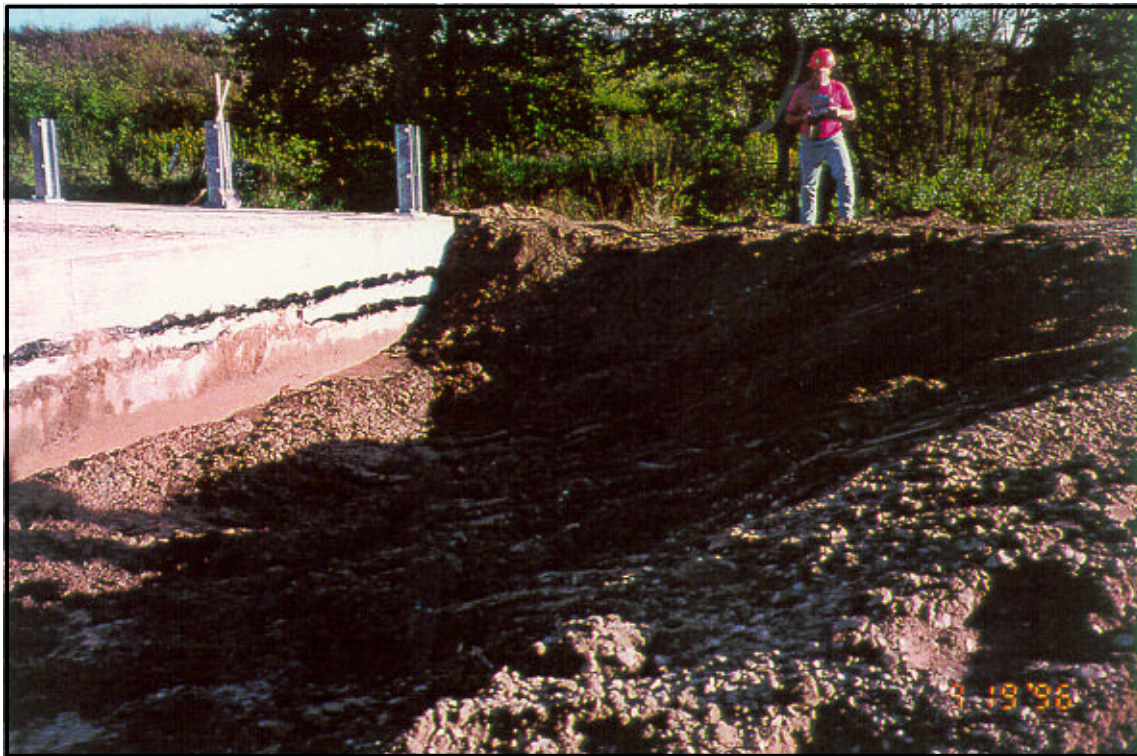
Print 2 - CTH D West bridge abutment after conventional aggregate used to “remove” standing water.

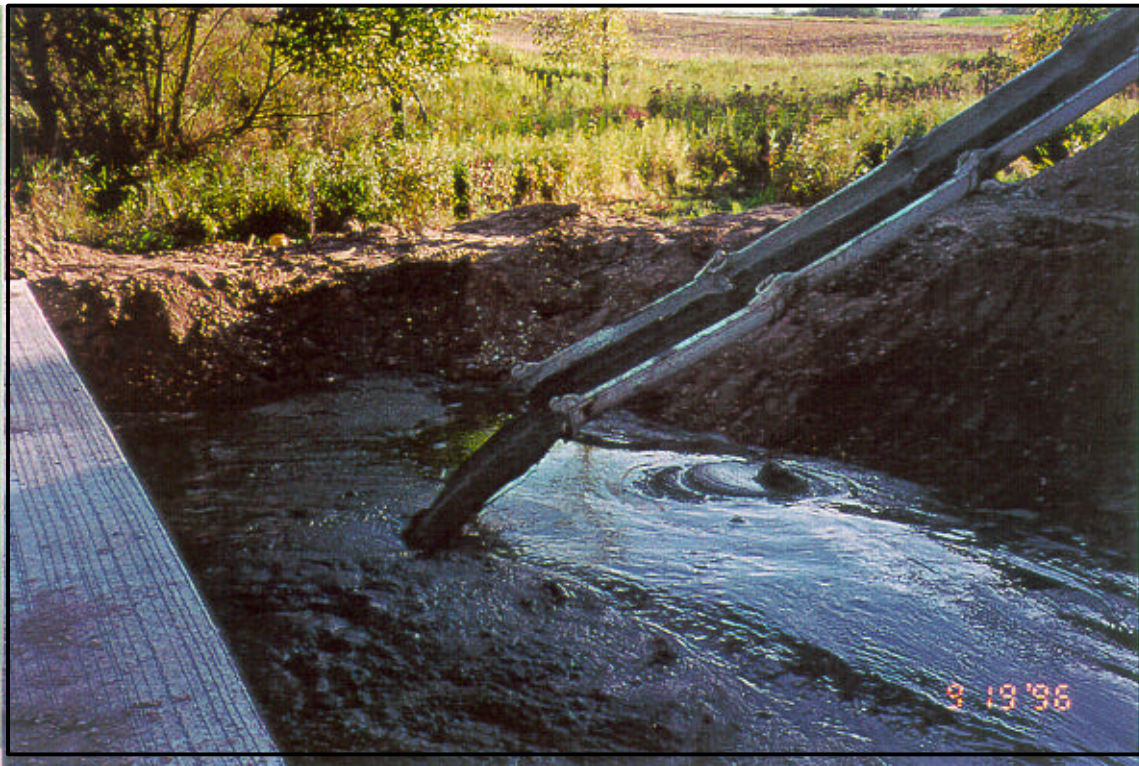
Print 3 - CTH D Showing placement of the CLSM.

After the fill was placed (using standard ready mix trucks) to the correct elevation, a crown to match the bridge deck was constructed by placing extra fill at the centerline. The extra material placed at the centerline utilized less water in the mix in order to keep it from flowing away from the centerline. The finished surface of the fill was 9" to 10" below the surface of the bridge deck. A total of 45 yds. (5 ½ truck loads) of flowable fill was used. It was noted the consistency of the slurry varied somewhat between truck loads and that the first truckload appeared to be more fluid than the others.

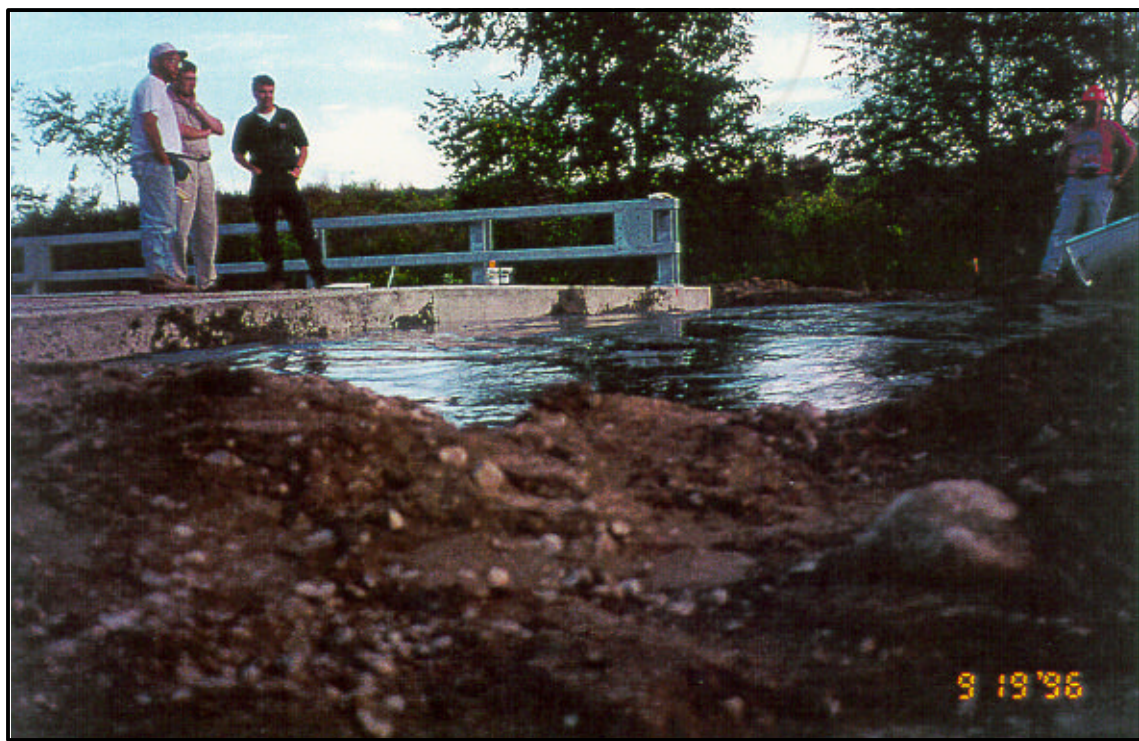
Print 4 - CTH D Showing completion of the CLSM placement.

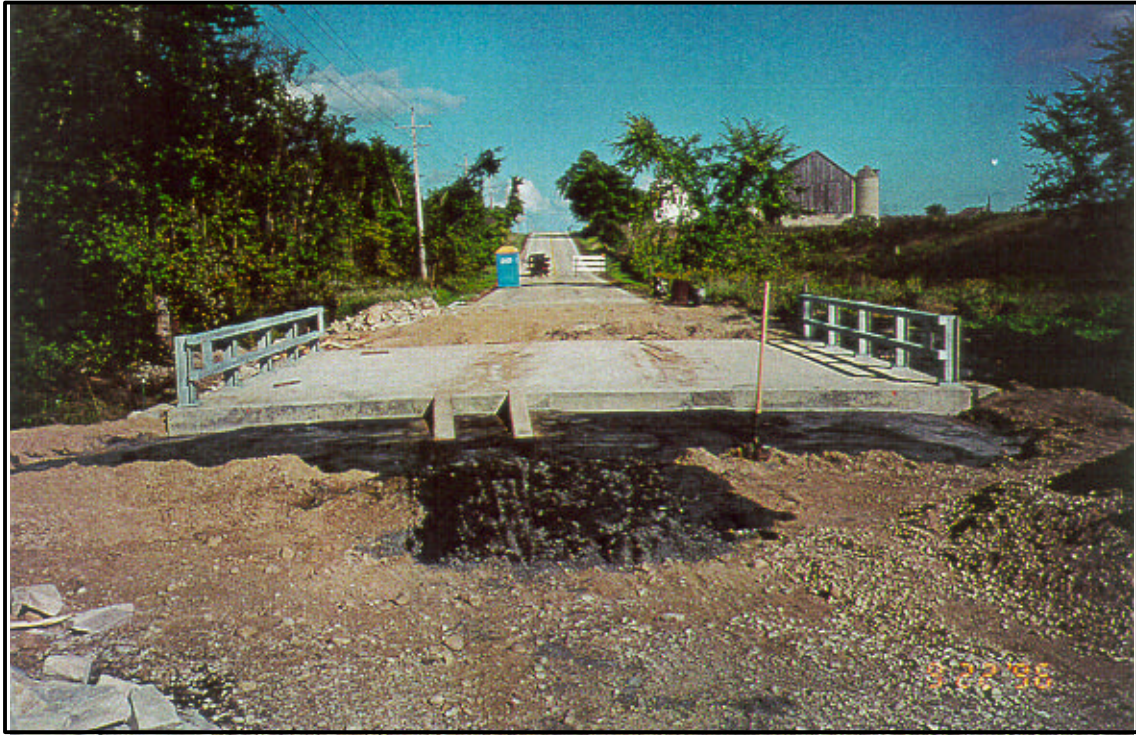
Print 5 - CTH D Looking East, CLSM @ 3 days after placement.

During an on-site inspection on October 2, 1997 (13 days after placement) it was found that the flowable fill was not setting properly. There was a thin crust (1-2 in.) on top of the fill, but the material below the crust could easily be shoveled like packed granular material or fly ash that had been compacted and watered in embankment fills³. It's quite possible the excess water in the trench delayed the set time. It was also observed that the material had not been covered with base course and was exposed to air.

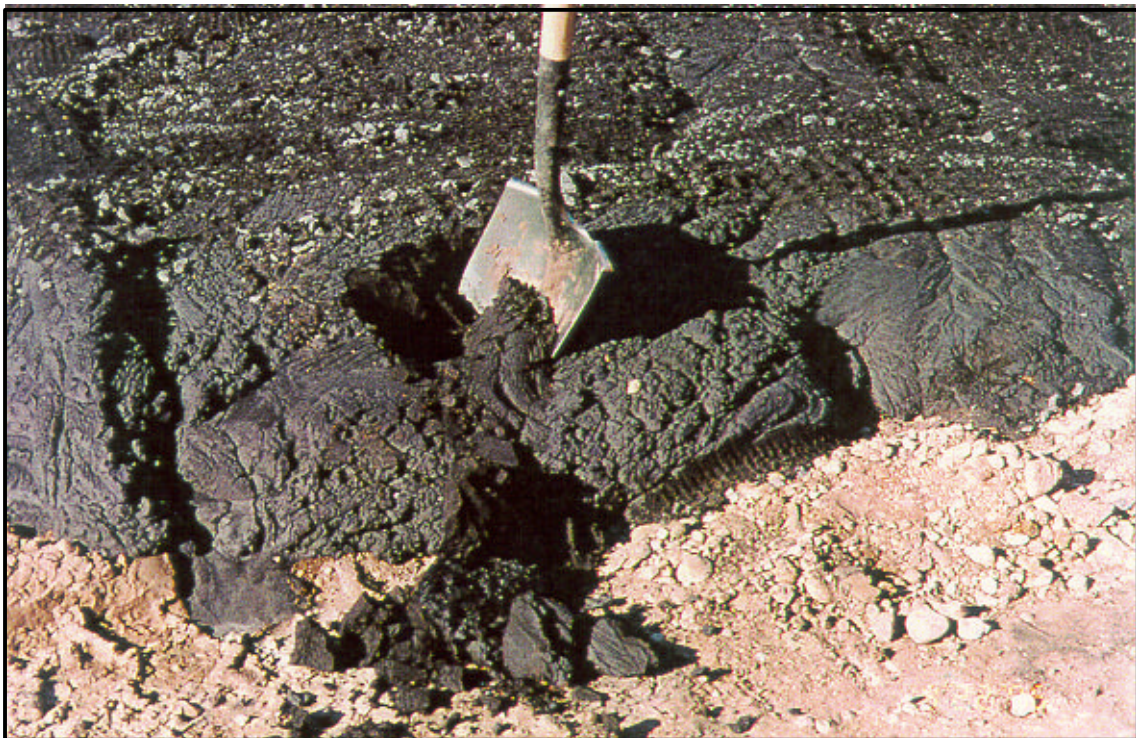
Print 6 - CTH D CLSM excavatable @ 3 days.

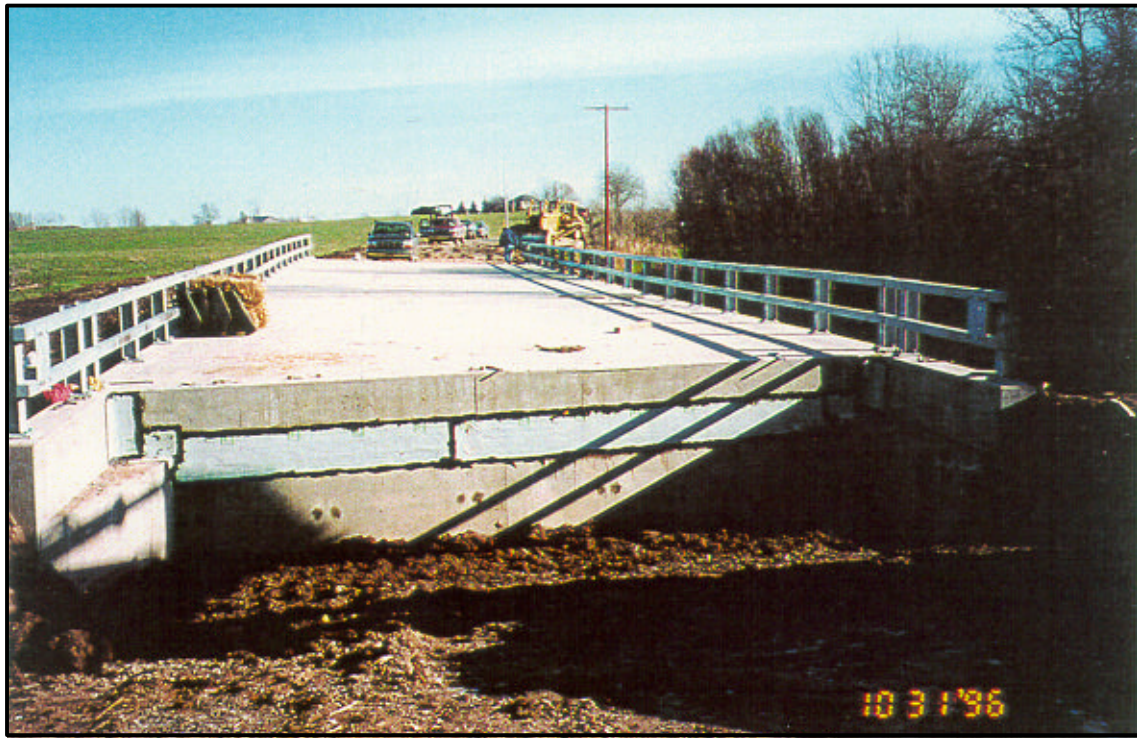
Print 7 - CTH G (Onion River) Showing west abutment site preparation.

The placement for the west abutment for this structure took place on October 31, 1996. Ambient air temperatures were 30° - 35° F. with 20 mph winds. The site was prepared according to plan dimensions (five feet at the face of the abutment, tapering to subgrade elevation at 25 feet). The natural soils used for the berms to confine the flowable fill were silt to silty clay and were saturated due to recent heavy rains. Water was not present in the trench as was the case with CTH D. The first seven truck loads had a very good consistency. The last two truck loads were noticeably "looser". In all, 72 yds. of flowable fill were used for this abutment. Again, standard ready mix trucks were used to haul and effectively place the fill over the entire area of the trench. No spreading was necessary and the material flowed well. As with the CTH D project, an attempt was made to match the crown of the structure by placing more material at the centerline. A *modified* slump test was performed on the second truck load and the result was 11 inches of spread. As noted earlier, the mix design for this fill utilized less water than that used for the CTH D which was thought to be too watery.

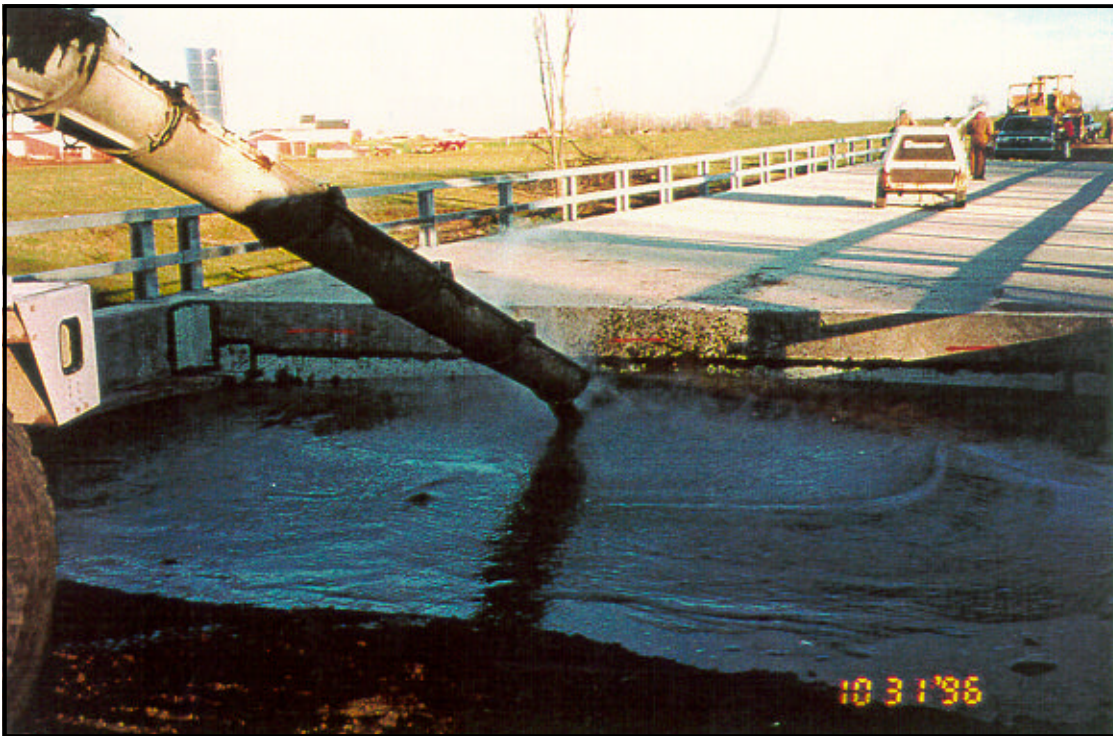
Print 8 - CTH G Showing placement of the CLSM on the west abutment.

The water was heated at the plant to give a faster set. It was estimated that the temperature of the

flowable fill when delivered at the site was 70° - 80° F. Due to low air temperatures (30° - 35° F.), the flowable fill was covered with plastic and straw in an attempt to aid set-up. The sheet of plastic used was 20 ft. wide and the fill area was 30 ft. wide, so the plastic was centered over the roadway leaving 5 ft. of flowable fill exposed on the outside edges.

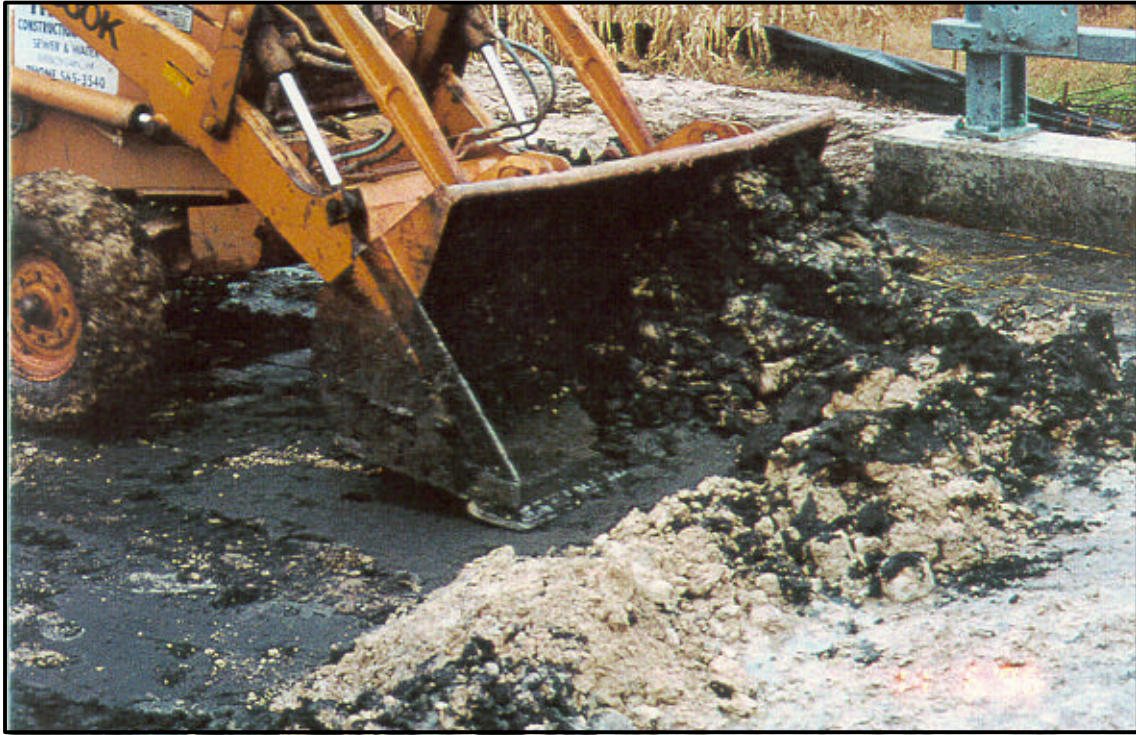
Print 9 - CTH G Showing the removal of the top 1.0 ft. of CLSM that didn't set.

As of November 12, 1996 (12 days after placement), the flowable fill was still mushy and had not set completely. In addition, trucks hauling base course gravel had rutted the flowable fill. Thus, the top one foot of moist material was removed and covered with a geotextile R fabric and an extra one foot of gravel to enable the contractor to pave the approaches. This reduced the length of the flowable fill area from 25 ft. to 20 ft and resulted in a base course two feet thick for this end of the structure.

It appears that the cold weather and the saturated surrounding soils significantly lengthened the set time. The cold temperatures likely reduced the rate of hydration and the saturated surrounding silty / clay soils may have prevented the release of moisture from the CLSM. In addition, the plastic covering that was used with the intent of keeping the heat in the mix to increase the rate of hydration may have actually contributed to the delayed set time by inhibiting the release of moisture from the CLSM.

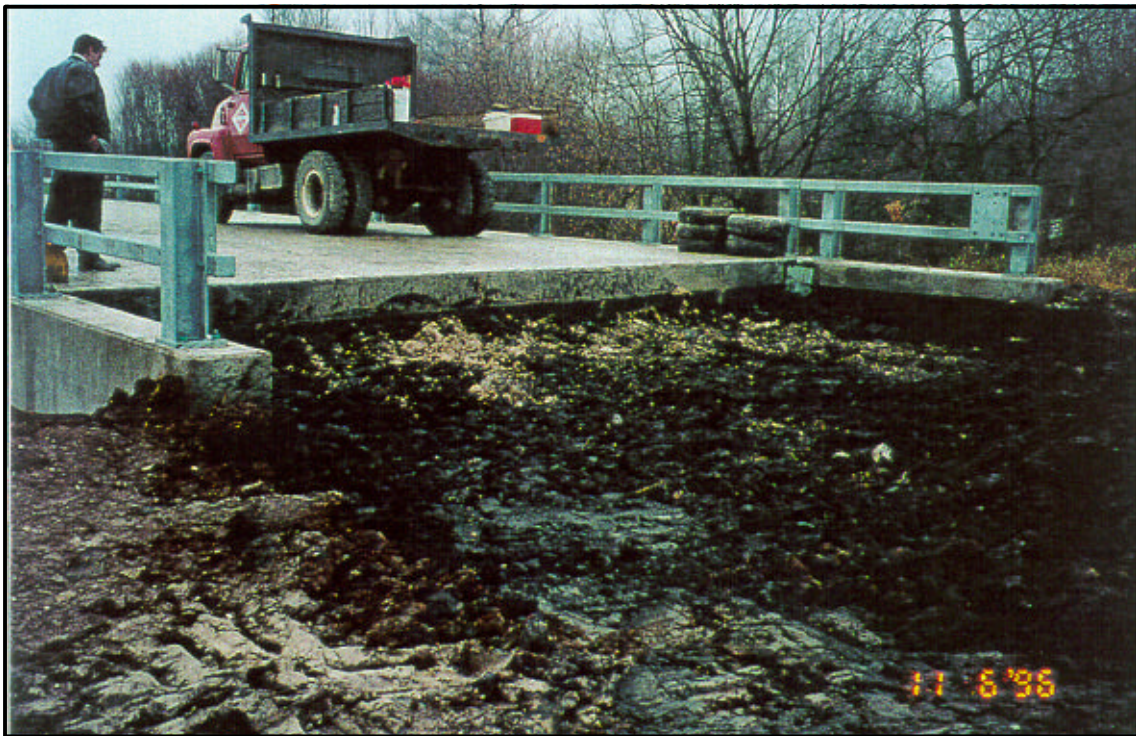
Print 10 - CTH G After 1.0 ft. of CLSM removed.

On the CTH G structure, the top one foot of CLSM was removed because it hadn’t set up completely. A geotextile R fabric and an extra one foot of base course (2.0 feet total) was then placed on top of the CLSM to enable the contractor to pave the approaches. The results from this structure may be “skewed” as well.

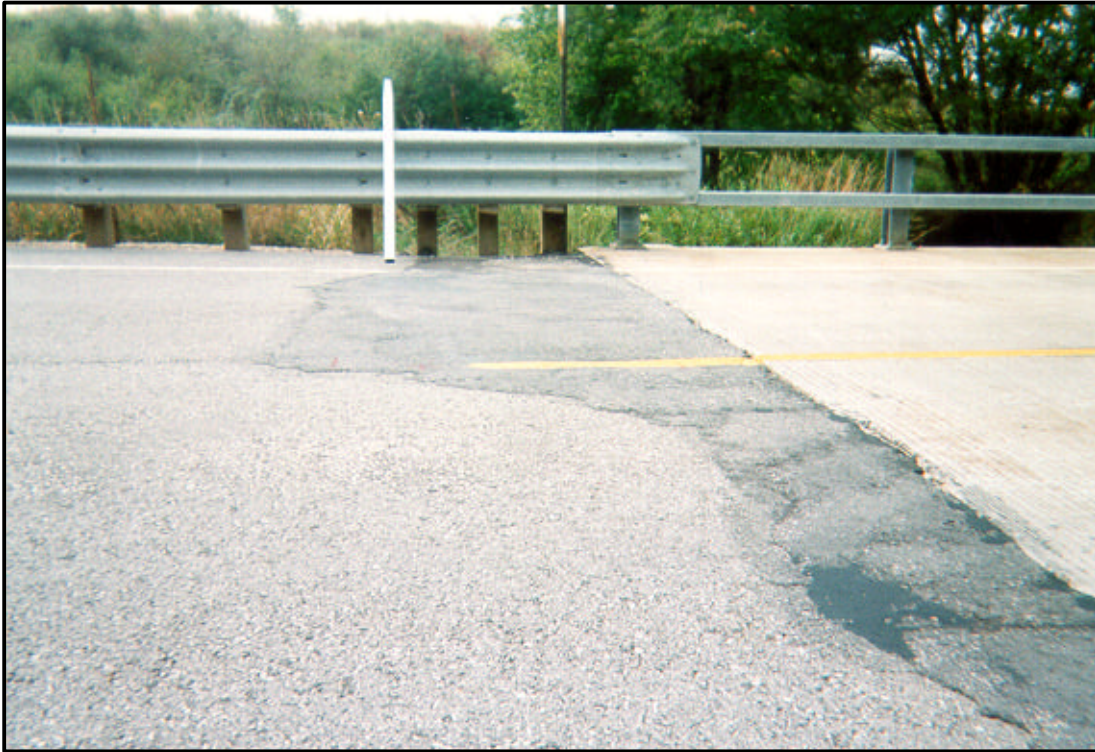
Print 11 - CTH D - East abutment patch.

Both ends of both structures were patched with a $\frac{3}{4}$ inch thick wedge of asphalt in October of 1997 and again in October of 1998 due to settlement of the approaches to the bridge decks. These patches extended approximately 12 - 14 in. out from the edge of the bridge decks, except the patch on the east end of the CTH D structure which extends out approximately 1 - 3 ft.

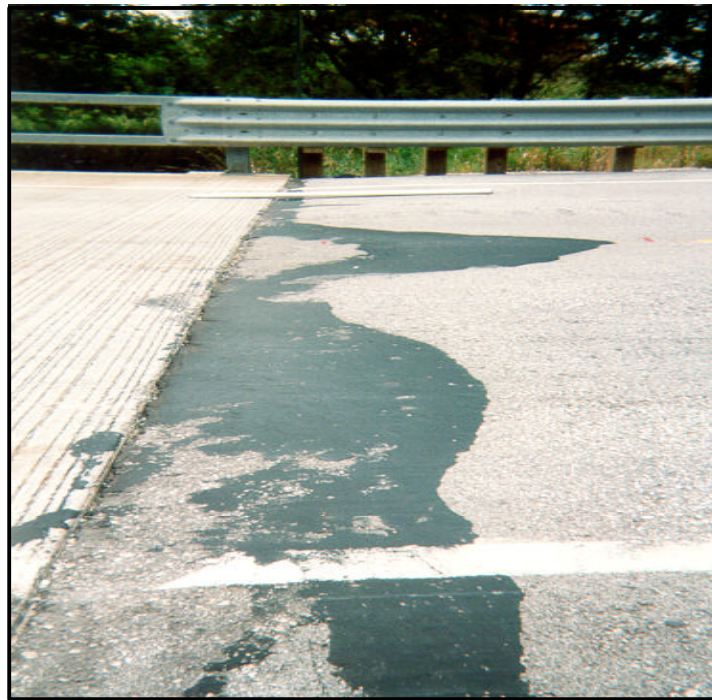
Print 14 - CTH D - West abutment patch.

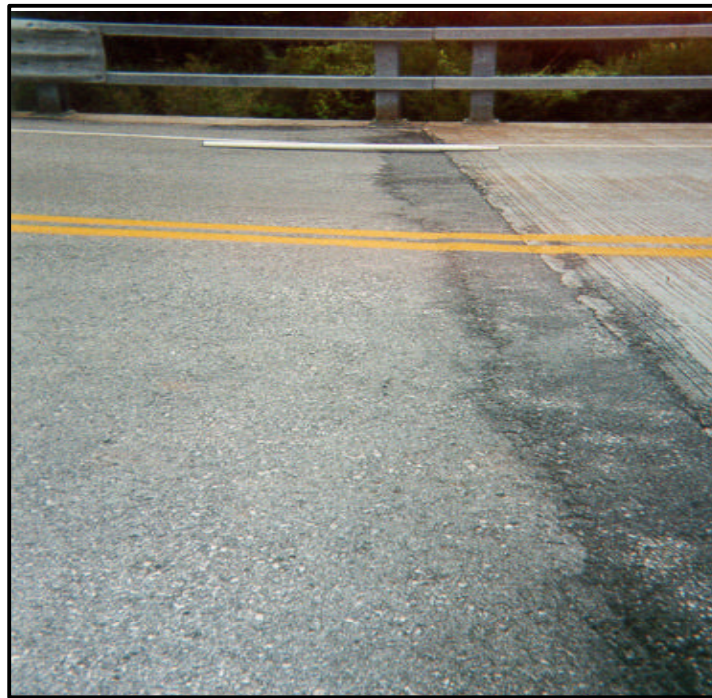
Print 16 - CTH G - East abutment patch.

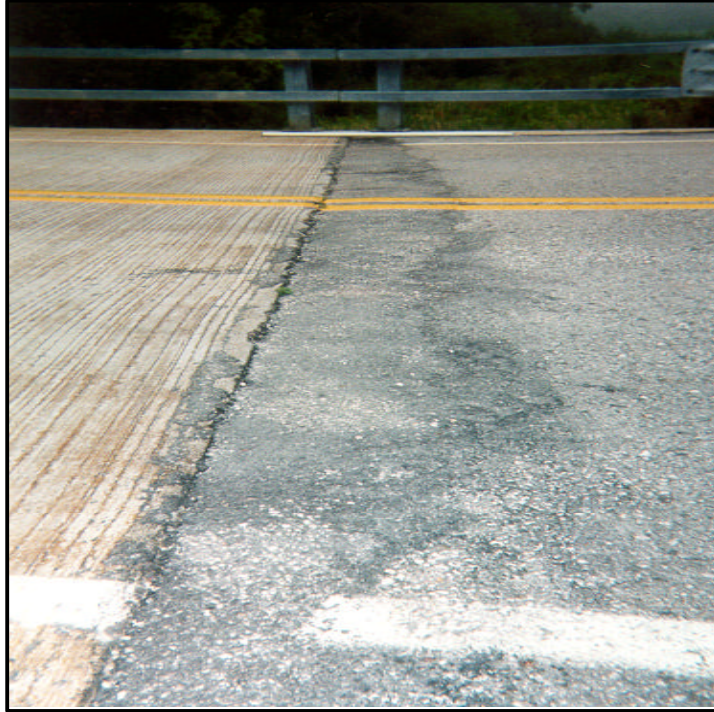
Print 17 - CTH G - West abutment patch.

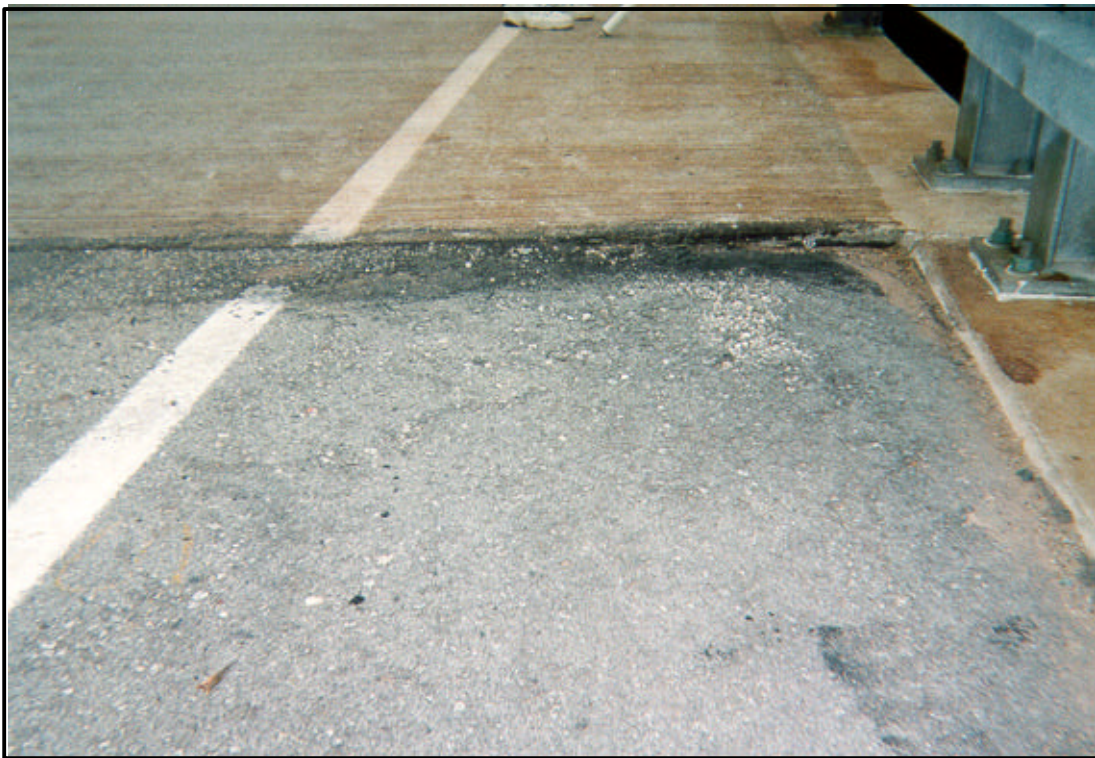
Print 18 - CTH G - West abutment south shoulder not patched.

The concrete bridge deck was in excellent condition and void of any cracking. The paved approaches were in good condition except for some slight rutting. There was one 15 ft. long longitudinal crack on the south shoulder of the east approach. This crack was 23 ft. from the edge of the bridge deck. The asphalt patches placed in the fall of 1997 and 1998 were limited to the driving lanes, i.e. the paved shoulders were not patched. It was observed that the shoulders have settled with the south east shoulder approximately 0.75 in. below the bridge deck and the southwest shoulder approximately 2.0 inches below the bridge deck. The northeast and northwest shoulders did not show quite as much settlement, perhaps due to the sloping super elevation of the road.
